Guideline Assessment of newly delivered empty steel drums

Assessment of newly delivered empty steel drums

Introduction and scope

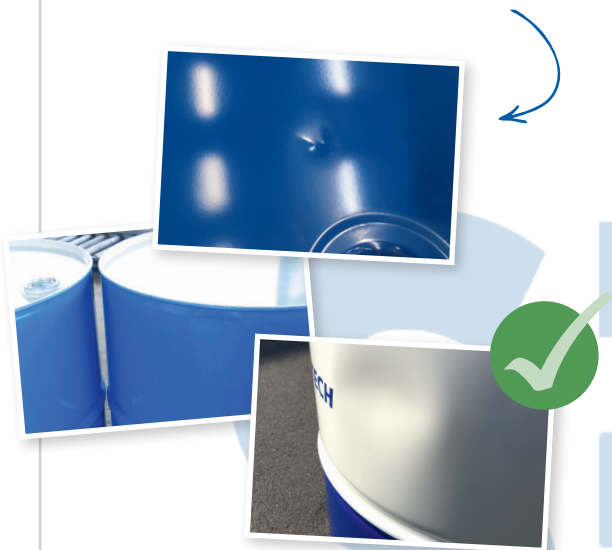
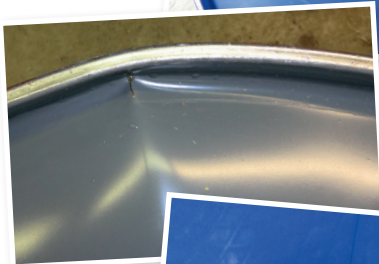
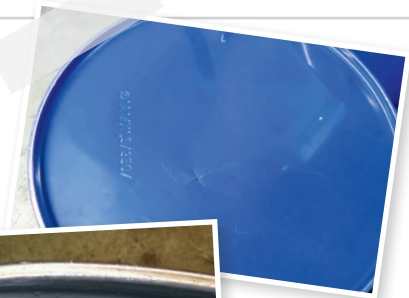
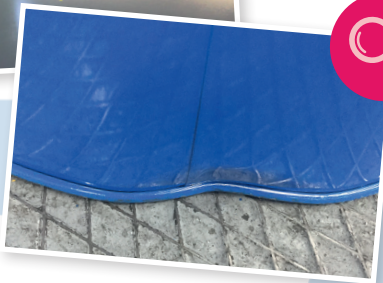
Dents and bulges

Smaller dents and isolated bulges of up to fist size on a steel drum's body and top end have no adverse effect on its serviceability.*

* In this regard, other assessment criteria can be applied for straight sided open head drums, in particular when the drums are emptied using follower plates.

A premature damage in the drum's bottom end can induce vibration damages, especially in longer-distance transport to the end customer or to intermediate destinations. We therefore recommend a visual examination of the bottom chime and bottom surface at least on a sample basis.

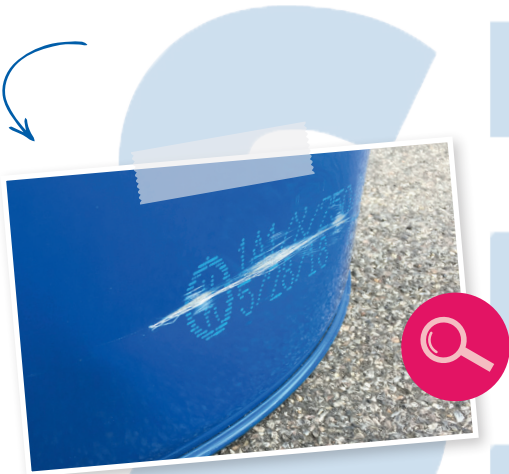
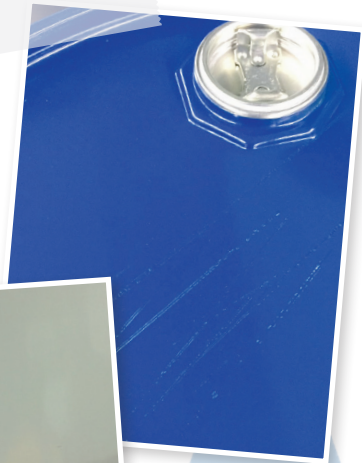
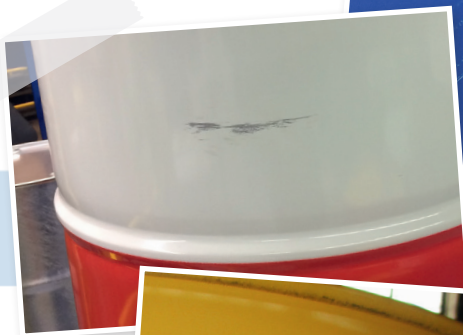
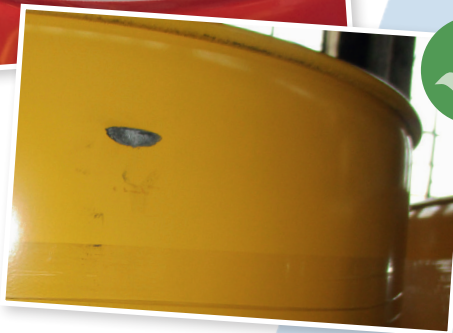
Surface scratches and abrasions

Scratches to the paint and abrasion, for example from sideboards in lorry cargo spaces and in swap bodies, generally have no influence on drum serviceability. Rather, these are purely visual flaws.

However, scratches must not detract from the clear and consistent legibility of UN markings.

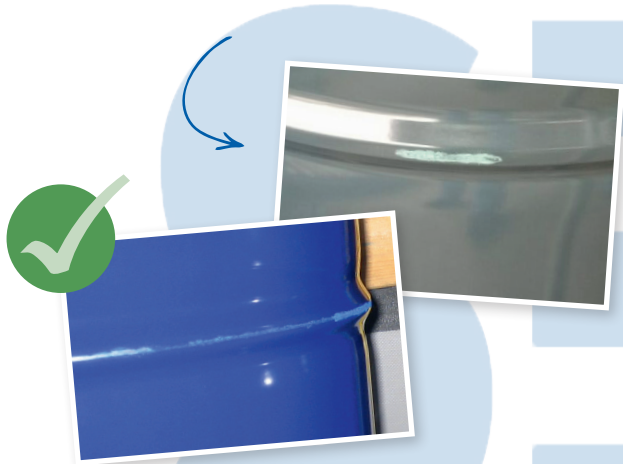
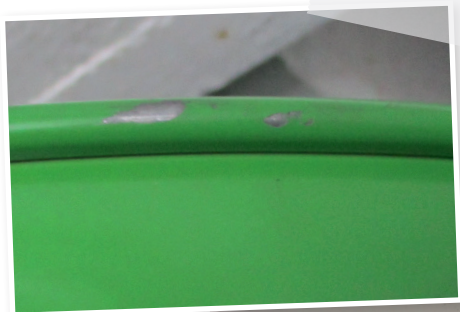
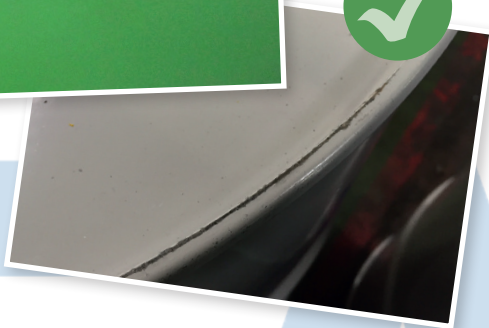
Scratches on the beads and chimes

As a rule, steel drums are manufactured with at least two circumferential V-shaped rolling beads in their bodies. Their resilience can be further increased by the inclusion of W-shaped rolling beads and additional corrugations. An added advantage of these special beads is that they facilitate the rolling of drums without damage to their straight surfaces. Scratches in the beads do not compromise drums' serviceability.

The mode of stacking used in transporting empty steel drums – for example on pallets or three-high loose – of course cannot be carried out in a non-contact manner. Accordingly, unproblematic abrasion to the chimes may occur. This can be reduced through appropriate, precisely determinable protective measures.

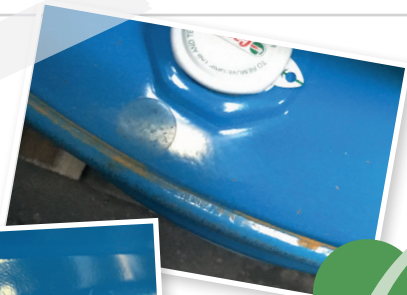
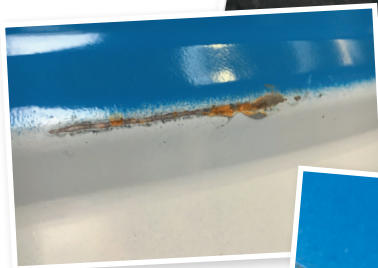
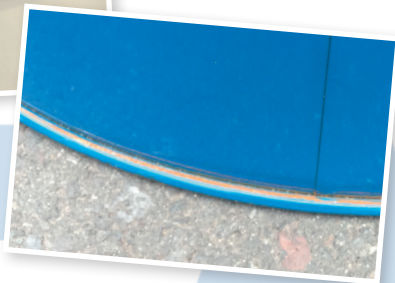
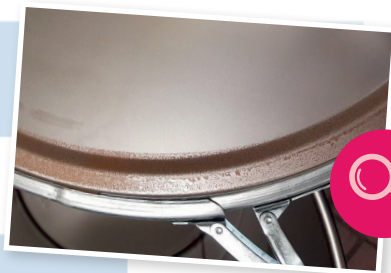
Rust

Steel drums should be protected from moisture and especially rain. For this reason, the empty drums are either shipped immediately after the final manufacturing step or palletised and placed in covered interim storage. Superficial rust damage that may nonetheless occur, poses no danger to drum contents. Given the thicknesses of the steel sheet employed, the material cannot be expected to fully rust through from outside to inside within the usual period of use, from the manufacturer through to the end consumer.

Empty open head drums are susceptible to the influence of moisture around the lid's rim when incorrectly stored, especially outdoors, but also when covered or on swap bodies. This can lead to the formation of rust on the underside after just a few days at low outdoor temperatures and high relative humidity.

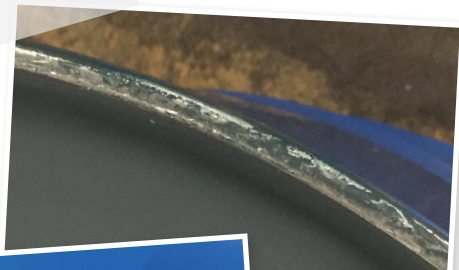
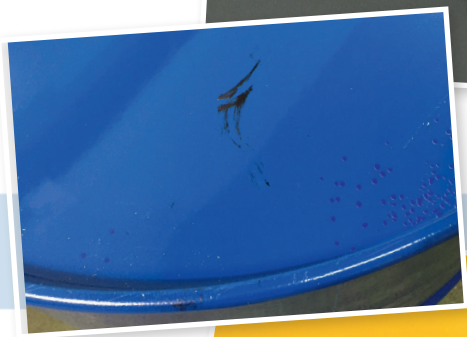
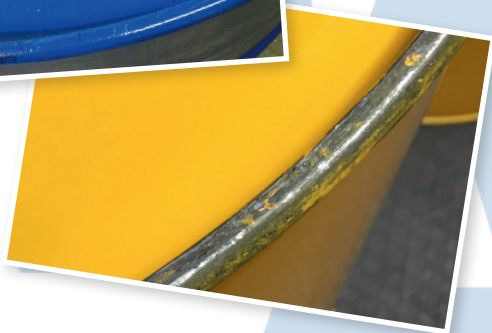
Soiling

Various oils and lubricants are employed in the operation of mechanical production plants and machines. The lubricants are used in optimised amounts and, for the most part, evaporate during the further production steps. The outer surfaces of a drum, however, do not undergo a final cleaning.

Over the course of production, the steel drums are conveyed by means of belts and chains, which likewise require lubrication.

To avoid paint abrasion, drum lids should always be removed with the drum in a vertical position and, especially importantly, the edges of the lid collar should not be set on the border of the drum or on other objects.

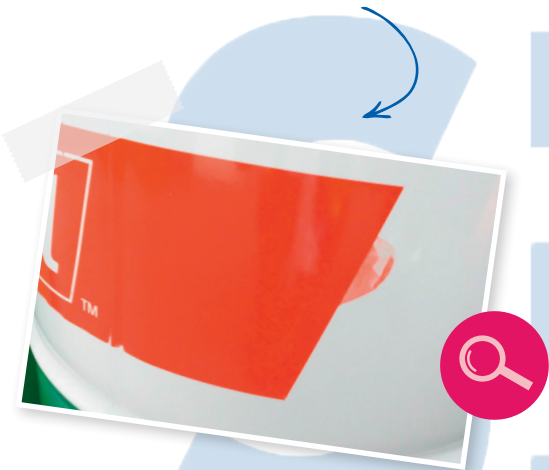
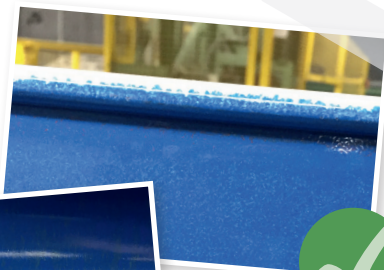
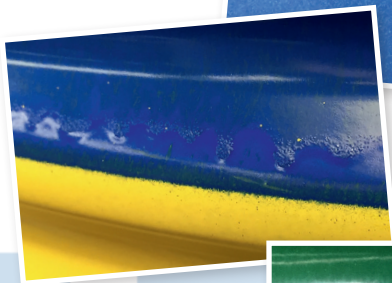
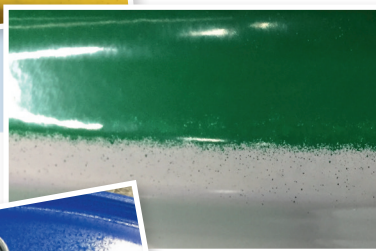
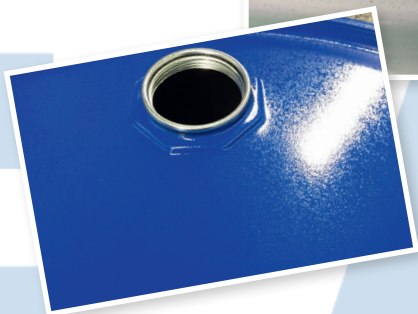
Paint irregularities

Slight irregularities in the paint surface, due to the brightness of the colour used or of the paint type, or in the colour transitions in the case of a multicolour design, cannot always be avoided.

However, the avoidance of blurring in the silk-screen printing of a logo or lettering, or a complete printed image, is considered a quality attribute.
